MEDICAL EFFECTS OF ATOMIC BOMBS

The Report of the Joint Commission for  
the Investigation of the Effects of the  
Atomic Bomb in Japan; Volume VI

July 6, 1951

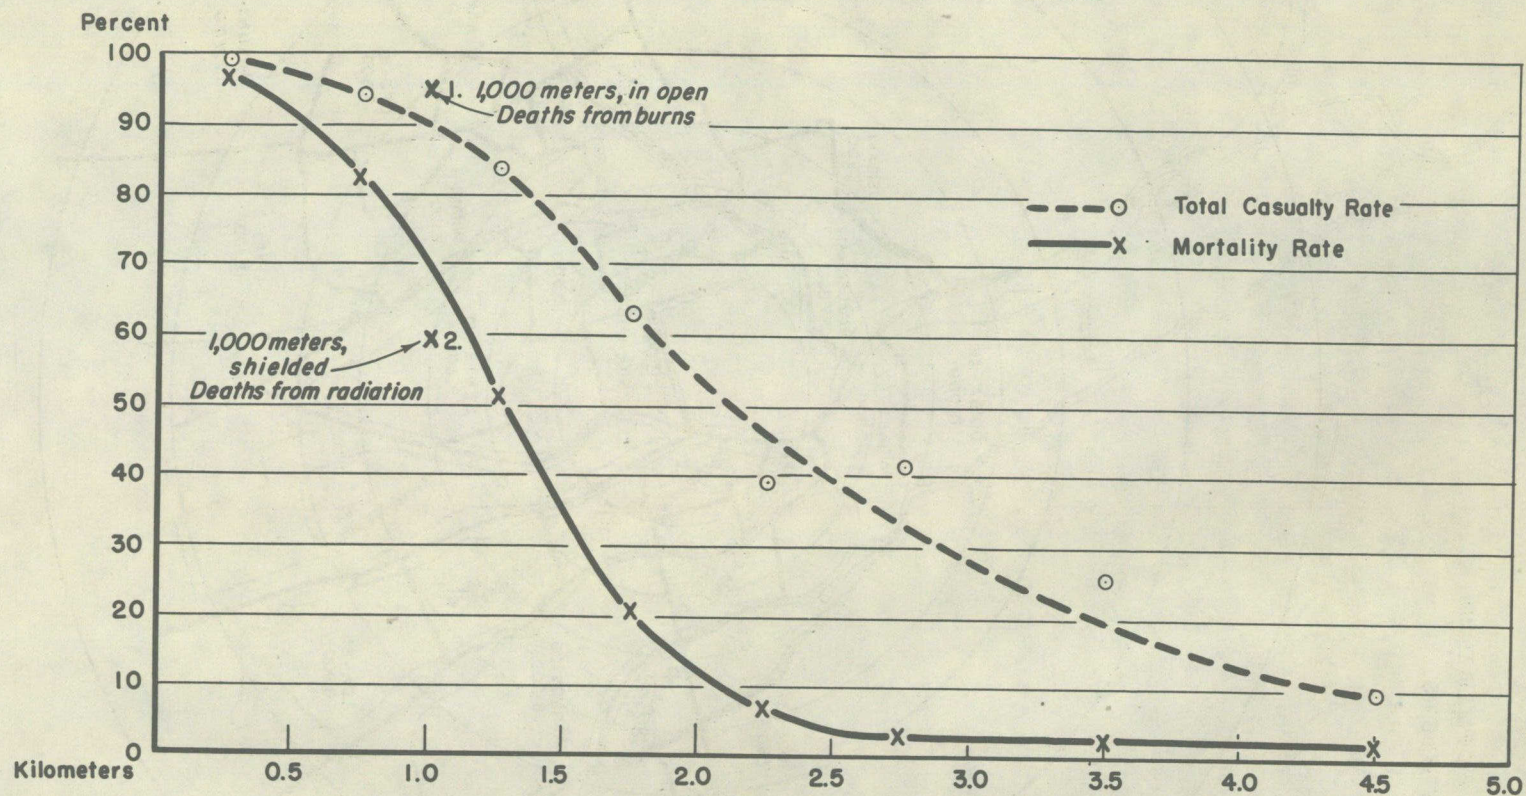
Figure 3--(10H). (Photo File # HP 157.)

## RELATION OF MORTALITY AND TOTAL CASUALTY RATES TO DISTANCE

At 1000 meters, in the open, the mortality from instantaneous burns is approximately 95%. The two points, shielded and unshielded, are plotted against the general mortality curve in figure 3.

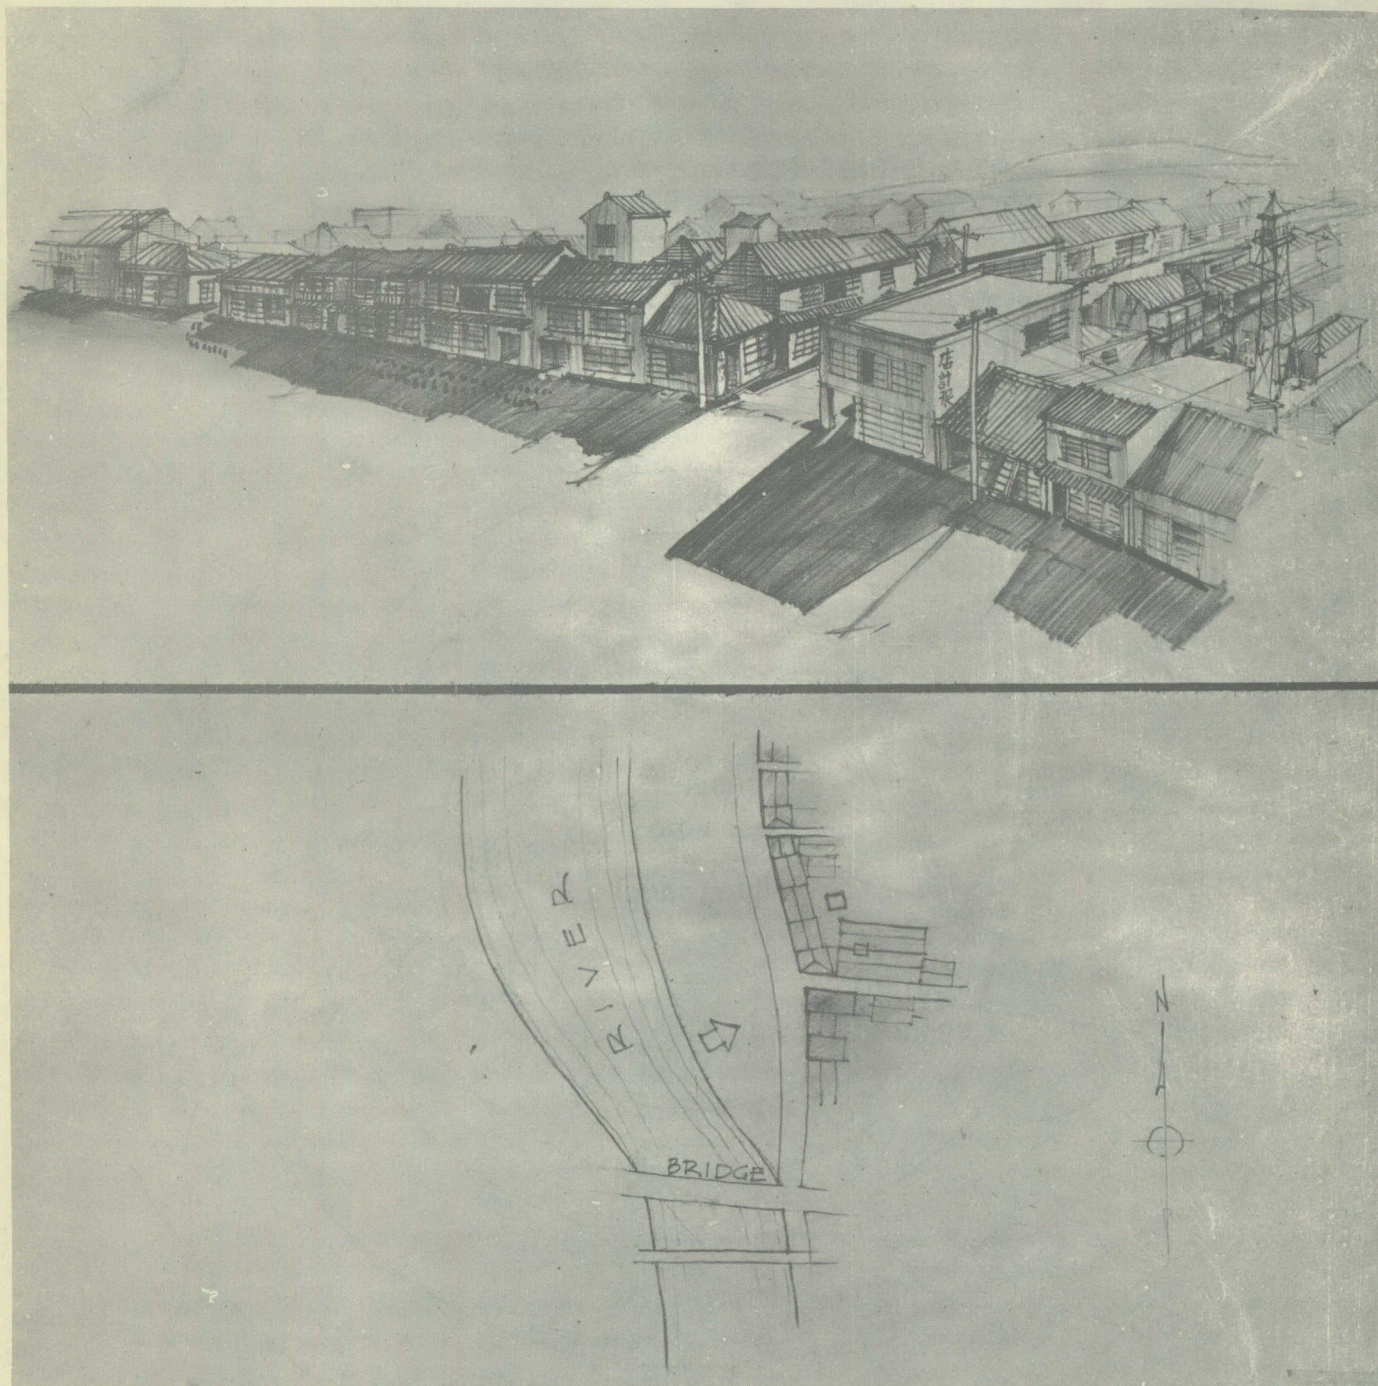
Figure 5--(10H). A reconstruction of the scene near the Temma Bridge. The street appears in perspective with the shadows cast by the buildings at the time of explosion of the bomb roughly indicated. The lower sketch shows the relation of the scene to the bridge. The arrow points to the center of the explosion. (Photo File # HB 324.)

a. Mr. Nagato's group was arranged in 5 subgroups in the vicinity of the Temma Bridge, in the position shown in the accompanying map (figure 4). Each subgroup consisted of between 24 and 30 men, a total of 135. In the reconstruction sketch of the scene\* (figure 5) all of the groups were standing in the shadow of the two-story buildings to the left of the large road. One group was at the far left where there was an alley-way and where the buildings were one-, rather than two-storied. Immediate burns appeared only in this group and 3 of the 10 men involved subsequently died of burns. Two others died immediately when a building collapsed, and one sustained severe contusions. All of the other men returned to Otake on foot. All subsequently showed evidence of radiation effect, manifested by loss of hair, and all but ten had petechiae. Seventy-two of one hundred thirty died of radiation effect, the first of these on 26 August and almost all by 13 September. None of these had more than trifling injuries. The incidence of radiation deaths in the various groups was as follows: Group I, 14 of 27; Group II, 15 of 27; Group III, 13 of 27; Group IV, 11 of 24; Group IX, 19 of 25.

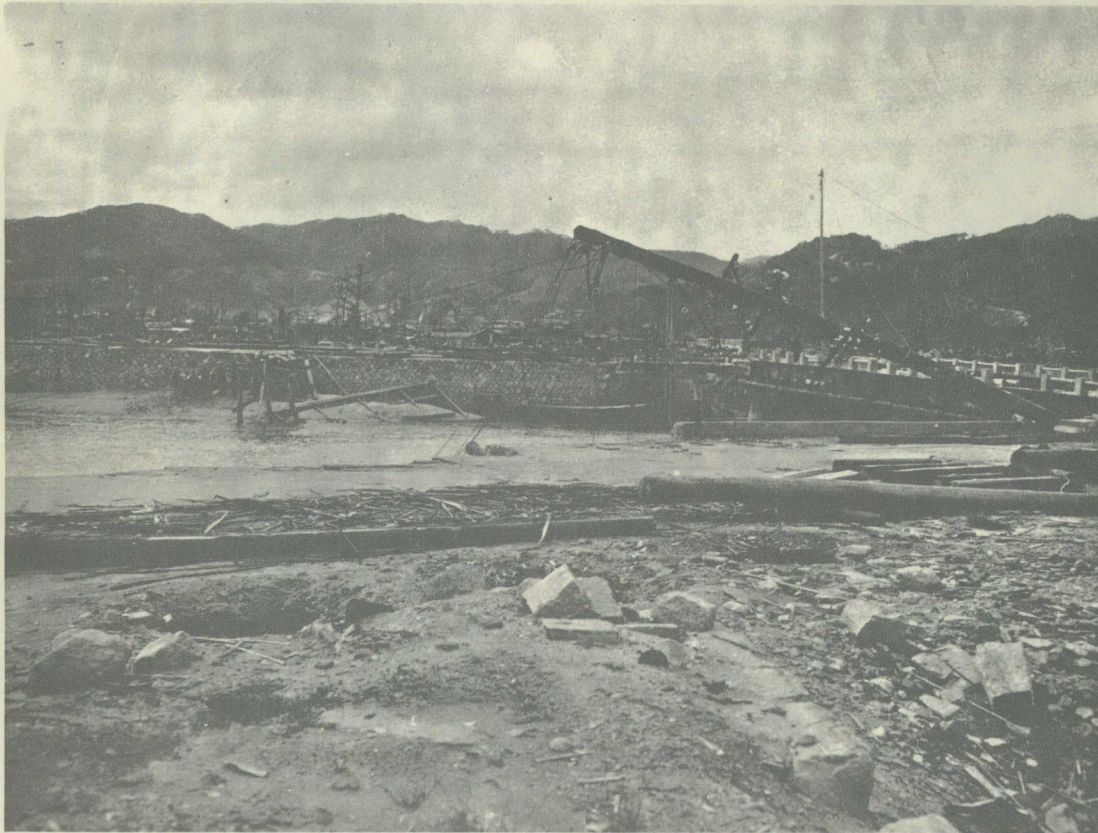
Figure 6--(10H). Bank of Temma River. Temma Bridge in background. Site under clearance for fire-break at the time of bombing by groups of men from Kuba and Ogata (Tachido and Mitsuishi Villages). Almost all of these died of burns. (Photo File # HG 270.)

a. A group of 106 individuals from Kuba village who were engaged in loading stone on the east bank of the Temma River near the Temma Bridge in the situation pictured in figure 6 all sustained severe burns. Forty-eight died on the spot or within 2 days, apparently as the result of burns. Most of forty-eight others died by 10 August, also apparently on account of burns but some lived until the 20th of August and 2 or 3 had evidence of radiation effect in addition to burns. Of the 10 who survived and in whom the burns healed, all had evidence of radiation effect and at the time of writing (20 November 1945) were still too weak to work. It may be assumed that those who died earlier also had radiation effects but these did not become manifest as sufficient time had not elapsed.

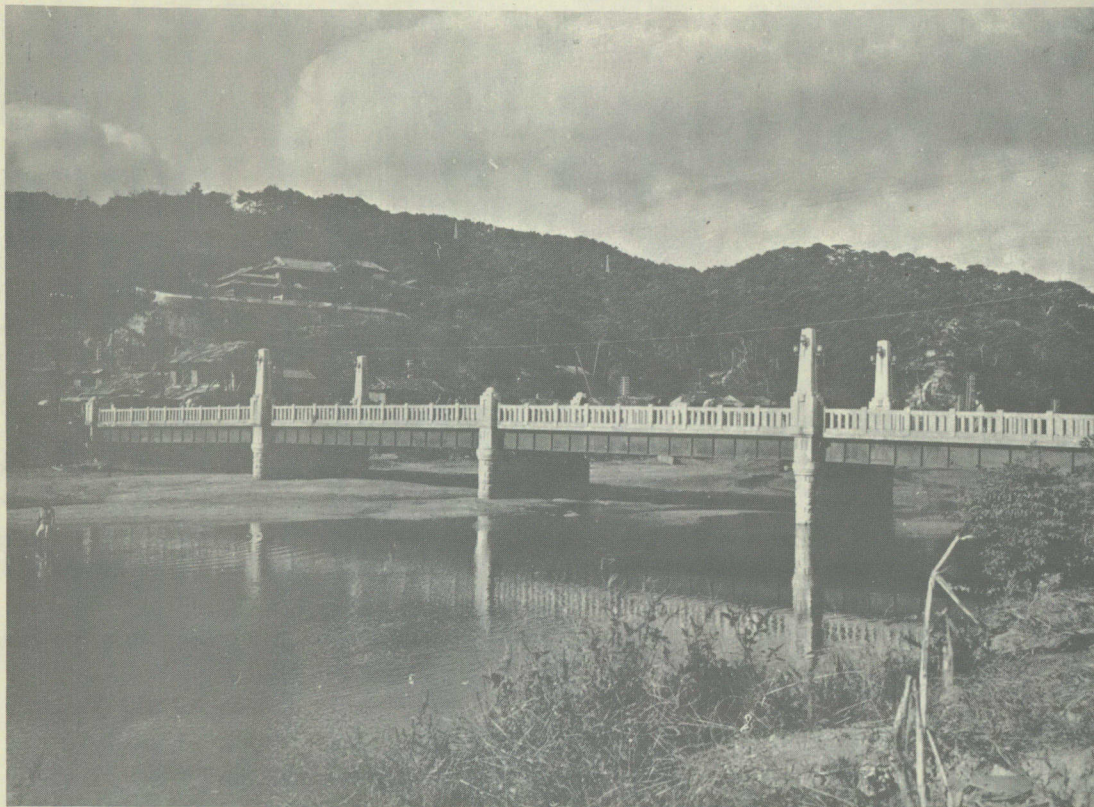
Figure 7--(10H). Koi Bridge, 2400 meters from hypocenter. The site where Foreman Hino's group from Otake village was exposed at the time of the bombing. The hills are on the Koi side. None is found on the Hiroshima side between the bomb and the people. These people were all burned, but they survived, with few exceptions. (Photo File # HB 323.)

The group, of which Mr. Hino was foreman, was on Koi Bridge, the location of which is shown in the accompanying map (figure 4) and a photograph of which is available (figure 7). These 580 individuals were on the march to Hiroshima. Only 1 of 10 subgroups was still on the bridge; the others were on the Hiroshima side. The buildings at this point on the shore were scattered and small. Two men were killed at once, the result of severe injury caused by a falling building. All of the other people sustained severe burns except three who happened to be beneath the eaves of a building. Seven women died within a week as the result of burns. All of the others survived and most of them were examined by the Joint Commission. There was no evidence of radiation effect in any of these people.

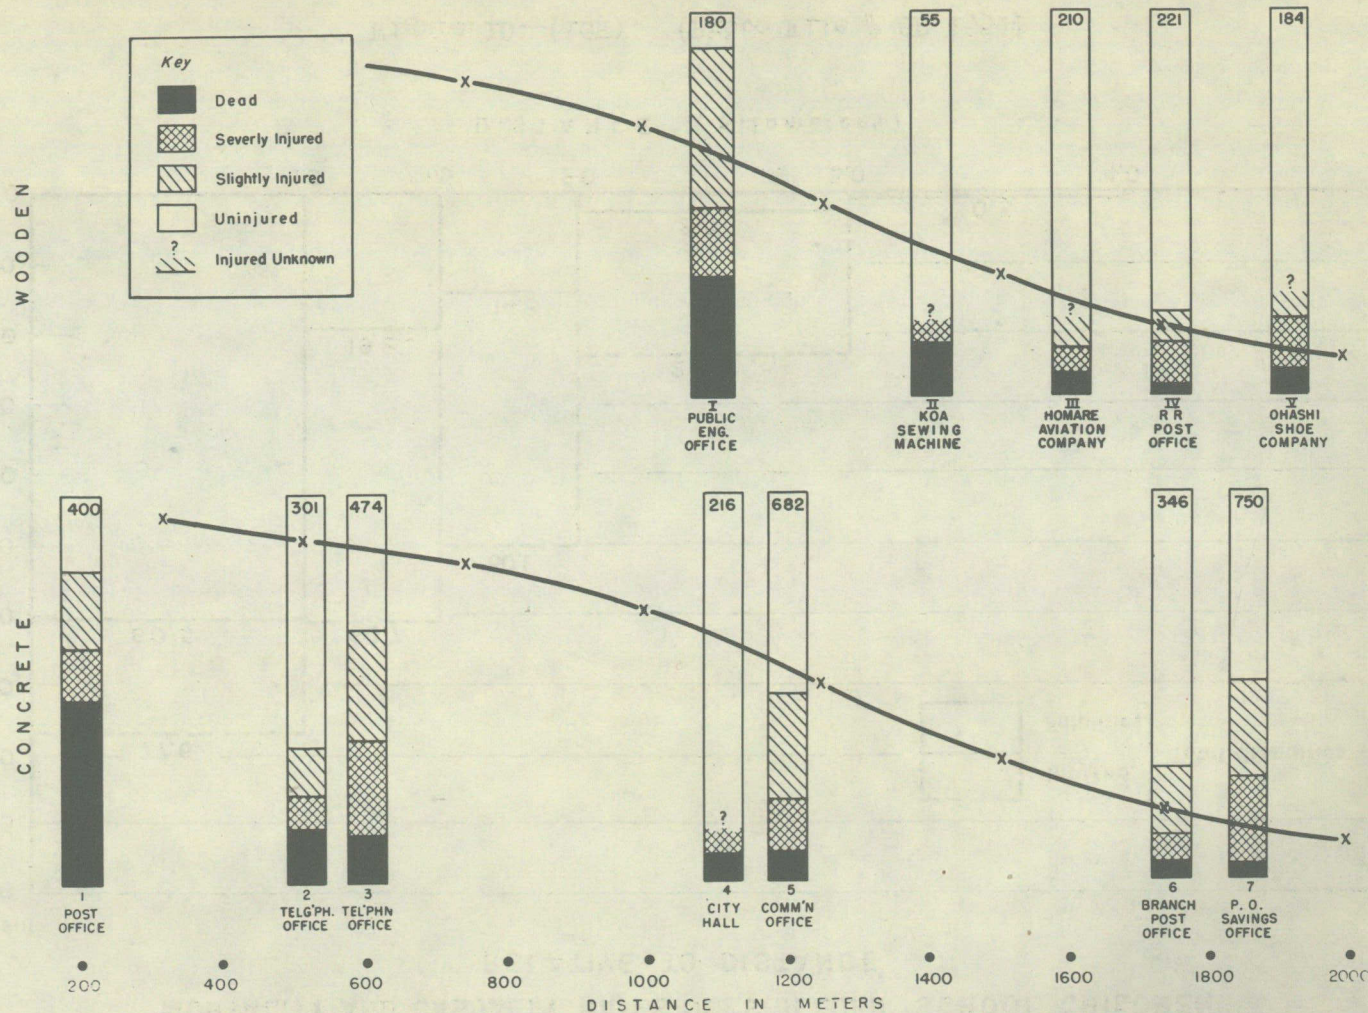
Figure 11--(10H). Comparison of Mortality and Casualty Rates (first 2 - 3 weeks) in Wooden and Concrete Buildings. The height of each column = 100%. The number of people in each building is indicated at the top of each column. Each column is placed in its proper relation to the point above which the bomb exploded.

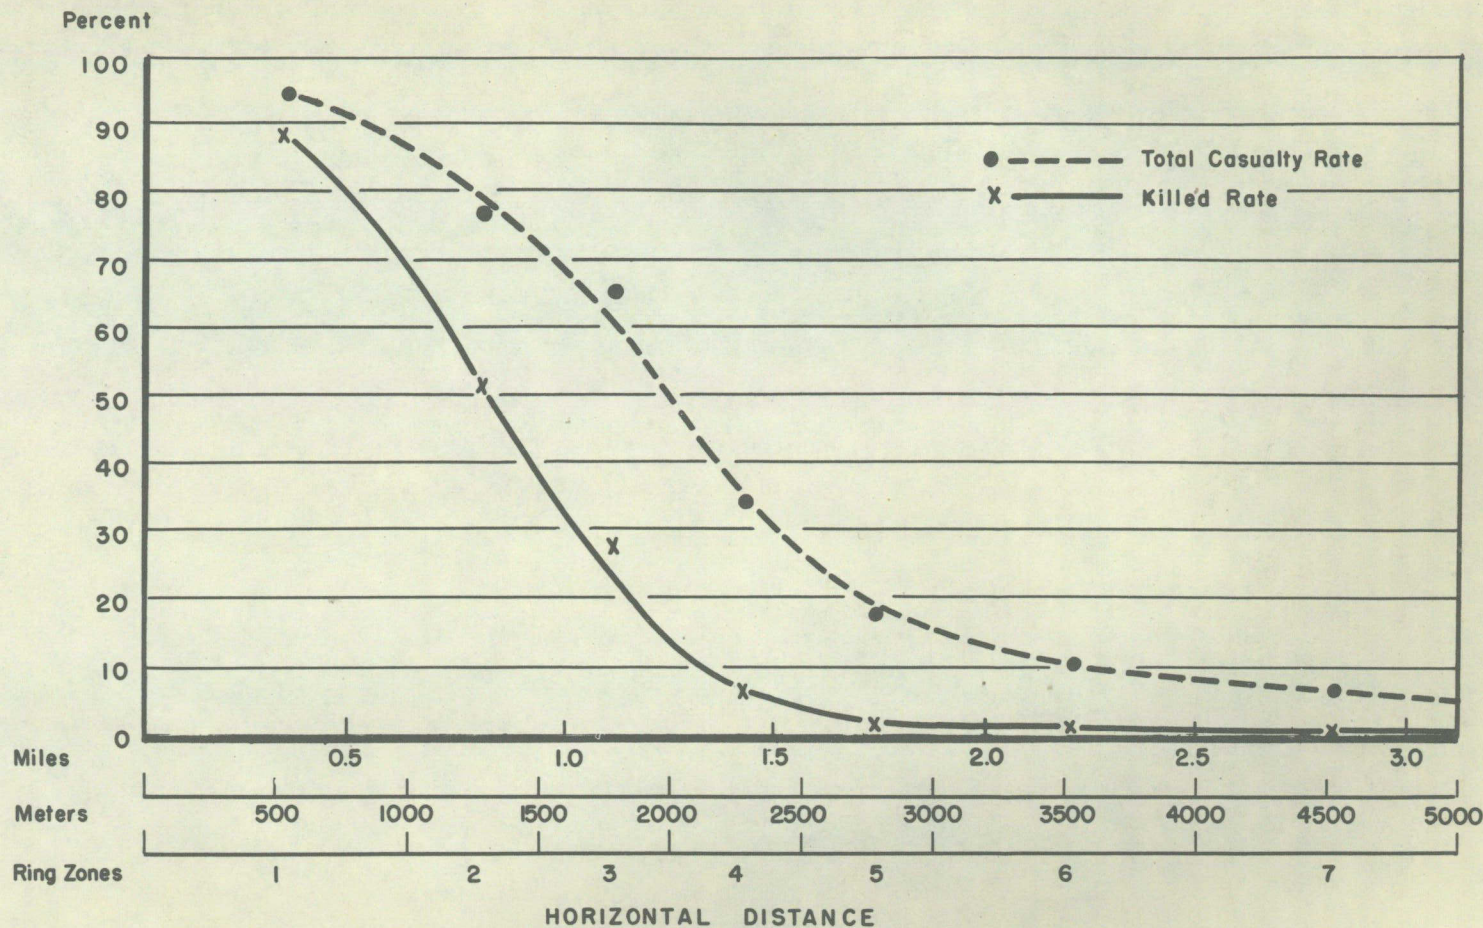
Figure 5--(10N). Smoothed curves of killed rate and total casualty rate. See Table 9 (10N). (Photo File # NP 166.)

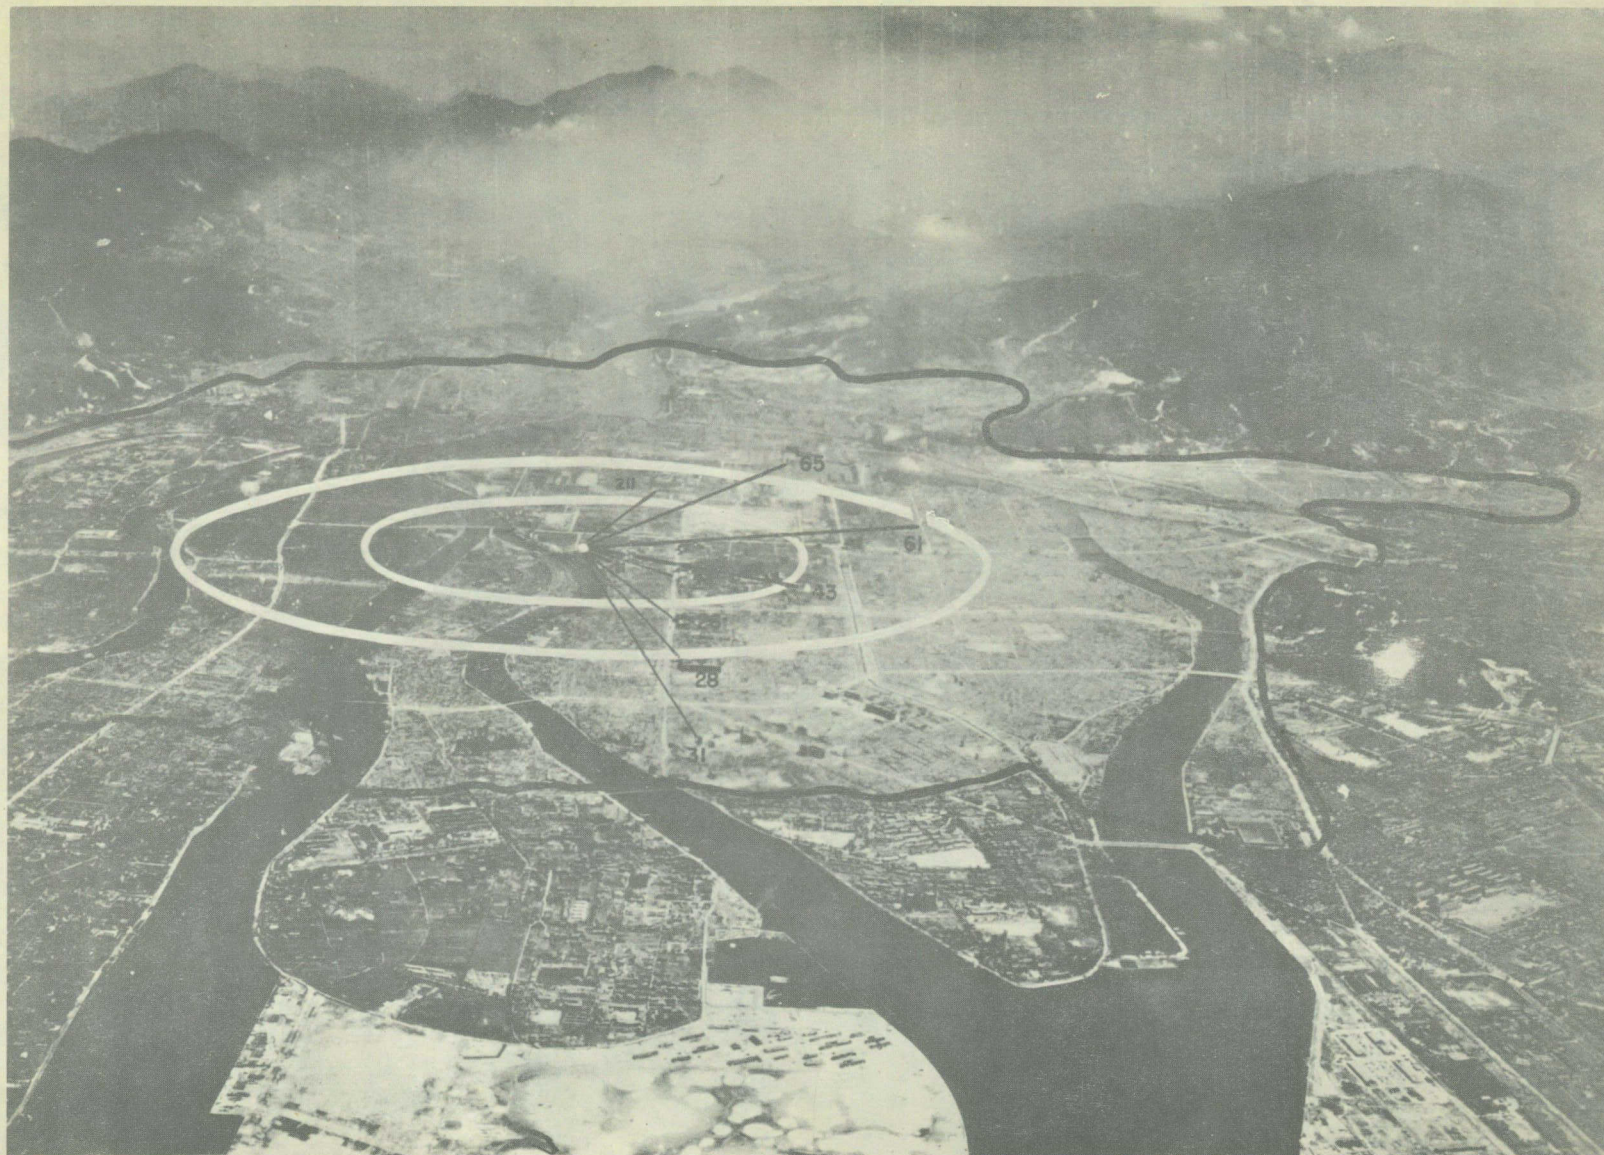
Figure 1--(11H). Buildings studied for correlation of shielding factors and survival. Radii are projected from the point above which the bomb exploded. The 500 and 1000 meter rings are indicated by the white circles. The zone of total destruction of the wooden buildings by blast and fire is outlined in black. (Photo File # Hg 271.)

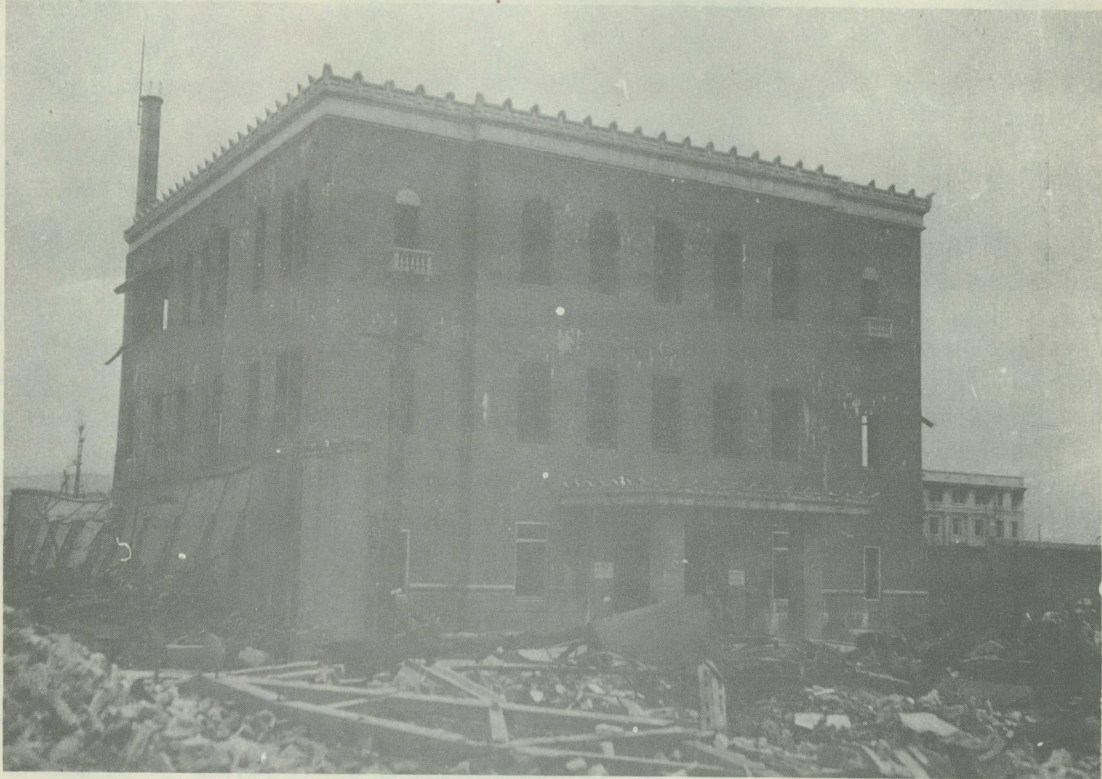
Figure 7--(11H). Bankers' Club (250 meters). General view looking away from the center of the explosion. Optical axis of camera in line with the point above which the bomb exploded. The wall at the left did not exert a shielding effect. The Nippon Bank can be seen to the rear and to the right of this building. (Photo File # HB 200; Date: 27 November 1945.)

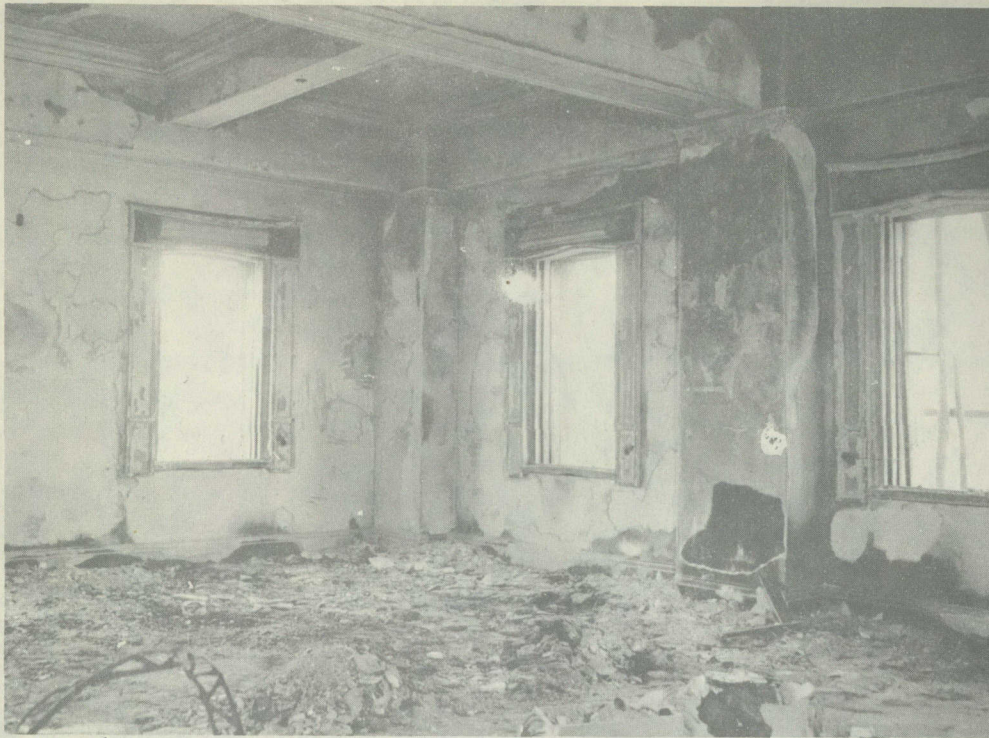
Figure 9--(11H). 450 meters. Nippon Bank. General view looking away from the center of the explosion. Optical axis of camera in line with point above which the bomb exploded. (Photo File # HB 203; Date: 27 November 1945.)

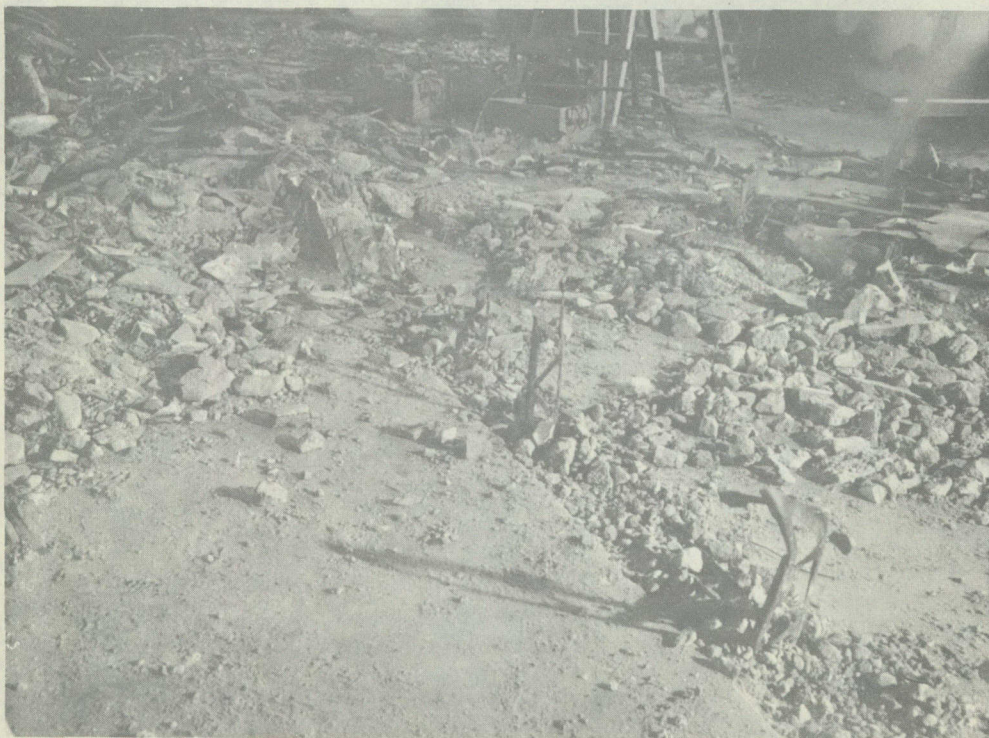
Figure 10--(11H). Nippon Bank (450 meters). Room-1, third floor. Camera facing toward the point above which the bomb exploded. (Photo File # HB 309; Date: 15 November 1945.)

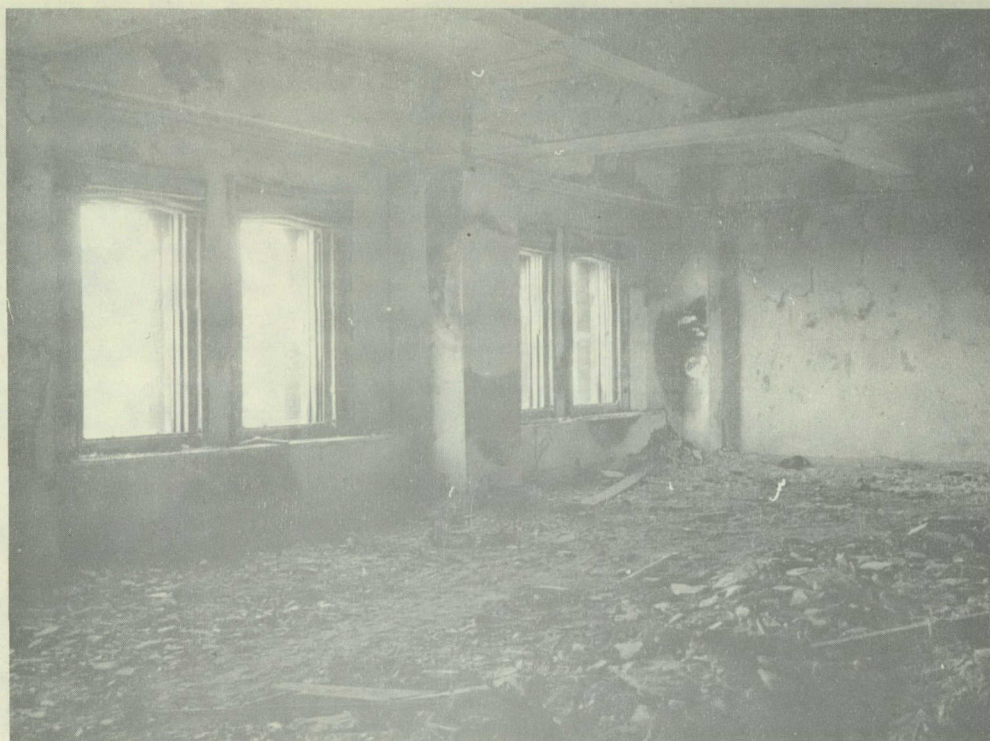
Figure 12--(11H). Nippon Bank (450 meters). Room-3 (third floor). Camera facing the point above which the bomb exploded. (Photo File # HB 312; Date: 15 November 1945.)

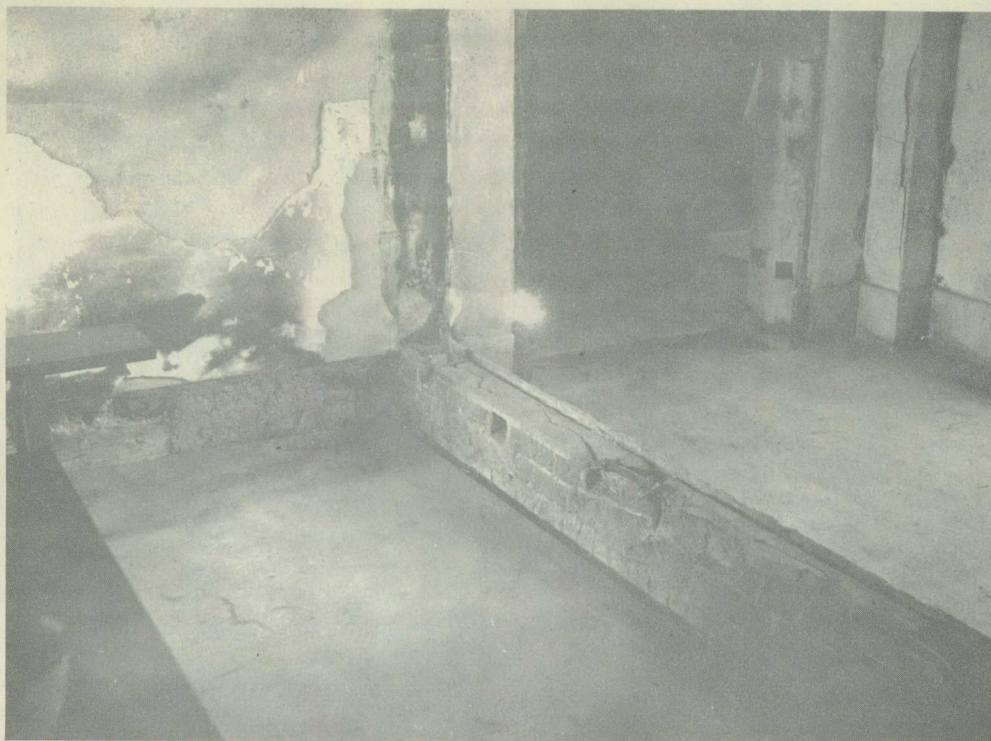
Figure 24--(11H). Telephone Bldg. (550 meters). Room A-2, second floor. Detail of base of partition. (Photo File # HB 318; Date: 15 November 1945.)

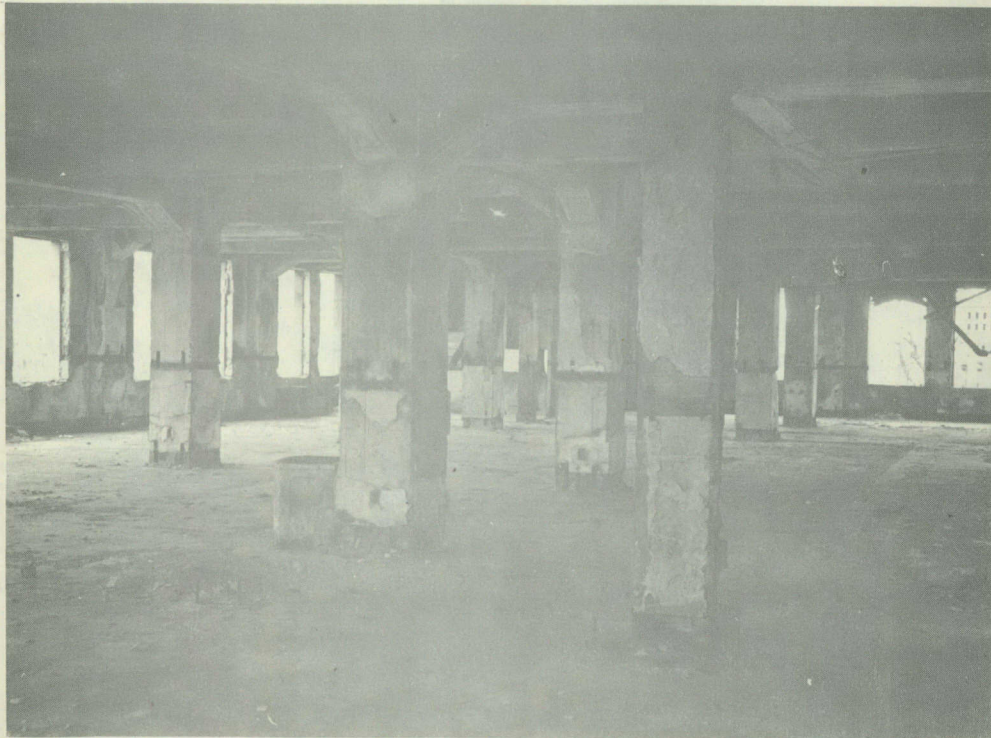
Figure 29--(11H). Chugoku Electric Bldg. (750 meters). Room III-1, third floor. Looking toward the center of the explosion. Compare with figure 26. (Photo File # HB 304; Date: 15 November 1945.)

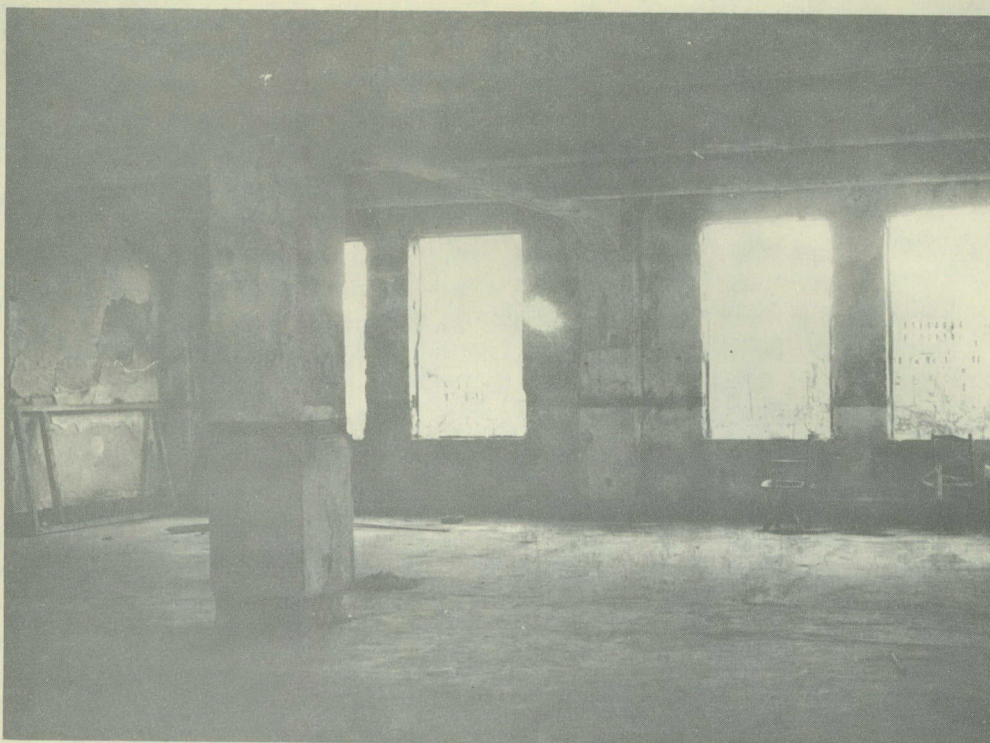
Figure 30--(11H). Chugoku Electric Bldg. (750 meters). Room III-2, third floor. Looking toward the center of the explosion. Compare with Figure 26. (Photo File # HB 305; Date: 15 November 1945.)

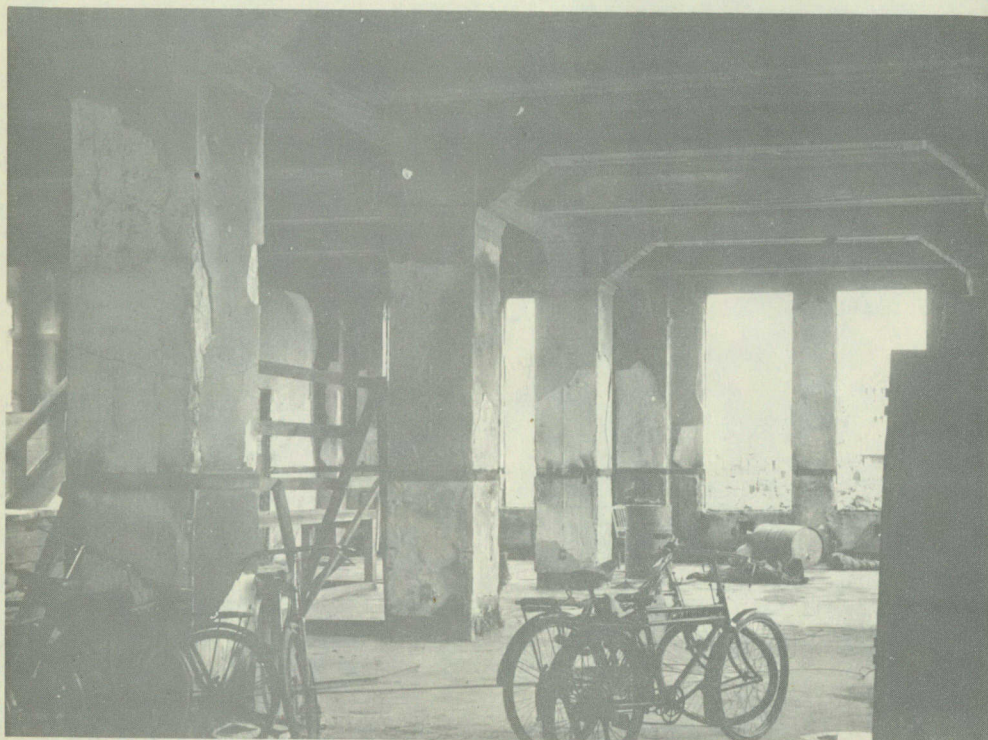
Figure 31--(11H). Chugoku Electric Bldg. (750 meters). Room I-1, first floor. The camera is pointed toward the center of the explosion. Compare with Figure 27. (Photo File # HB 300; Date: 15 November 1945.)

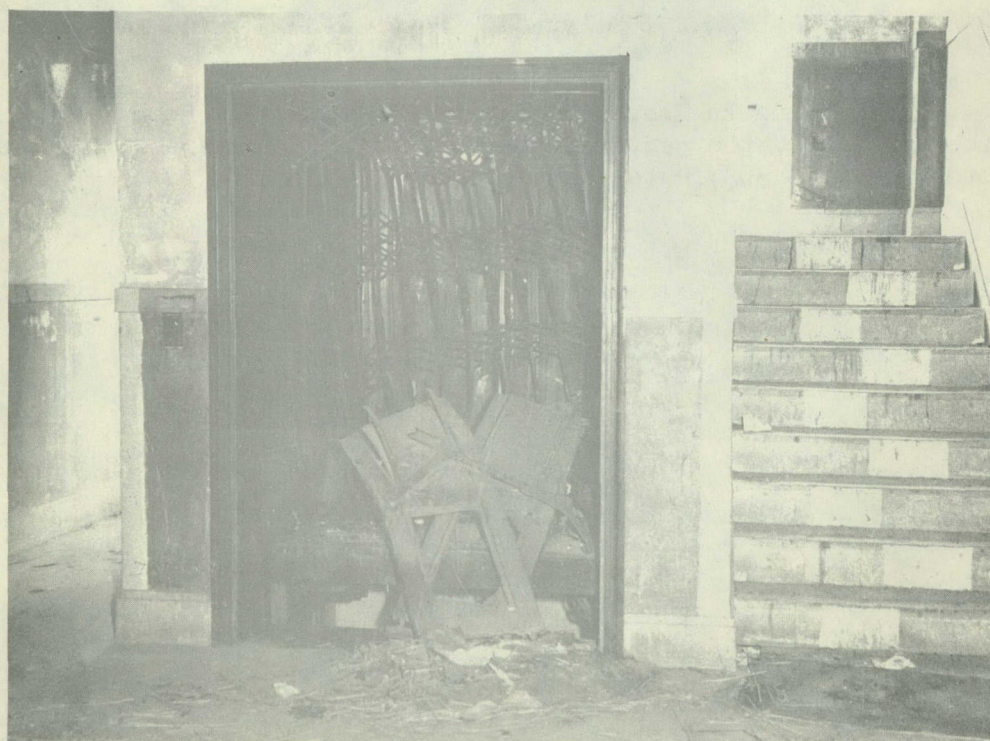
Figure 33--(11H). Chugoku Electric Bldg. (750 meters). First floor. Effect of the compression wave on an elevator and its housing. (Photo File # HB 302; Date: 15 November 1945.)

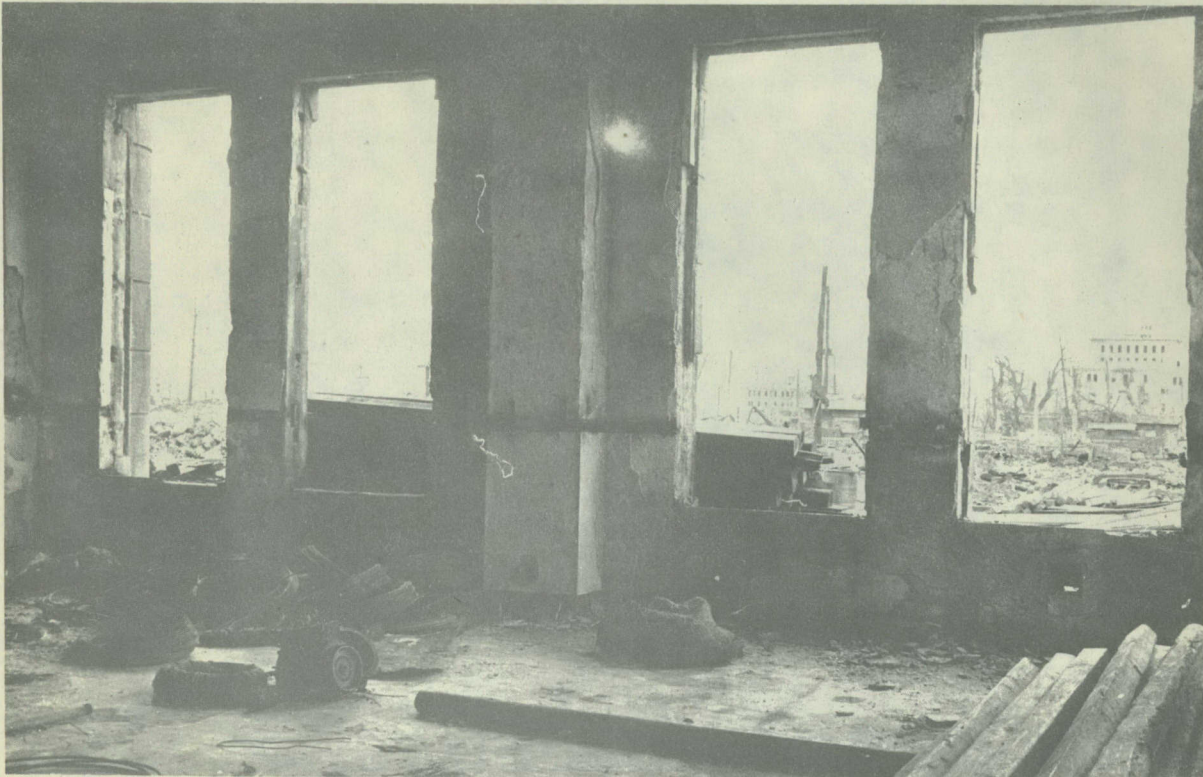
Figure 34--(11H). Chugoku Electric Bldg. (750 meters). Room I-2, first floor. Looking toward the center of the explosion. Compare with Figure 27. (Photo File # HB 303; Date: 15 November 1945.)

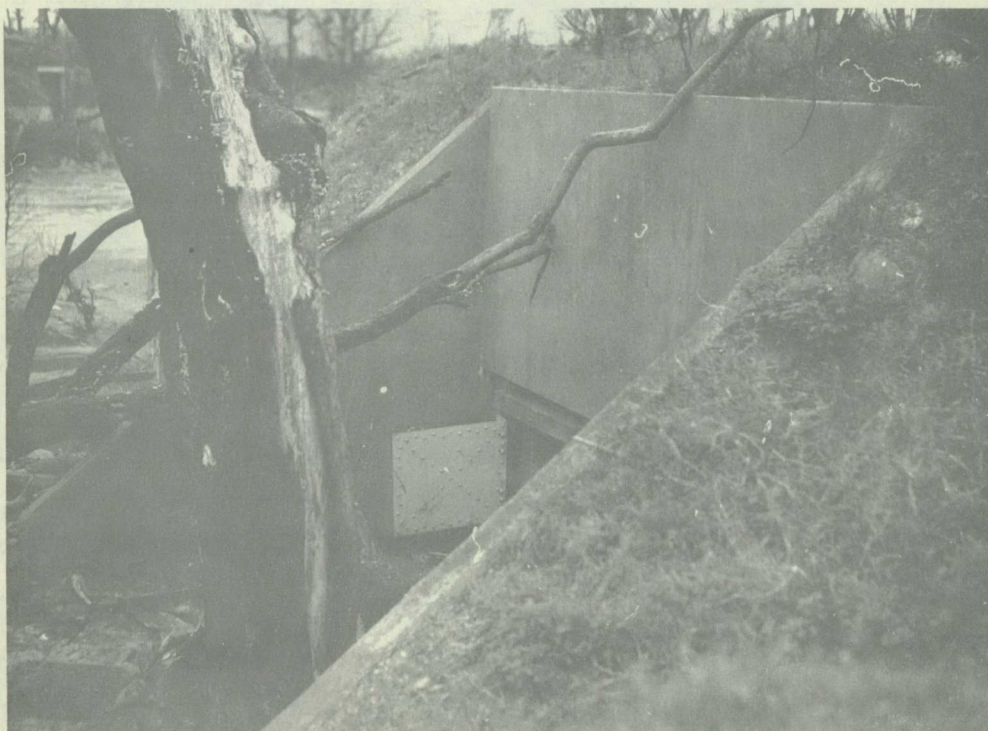
Figure 36--(11H). Chugoku Army Hq. (750 meters). View of the underground communications trench from across the moat looking away from the center of the explosion with which the optical axis of the camera is in line. The ventilator of the communications trench can be seen above the stone facing of the moat. (Photo File # HB 209.)

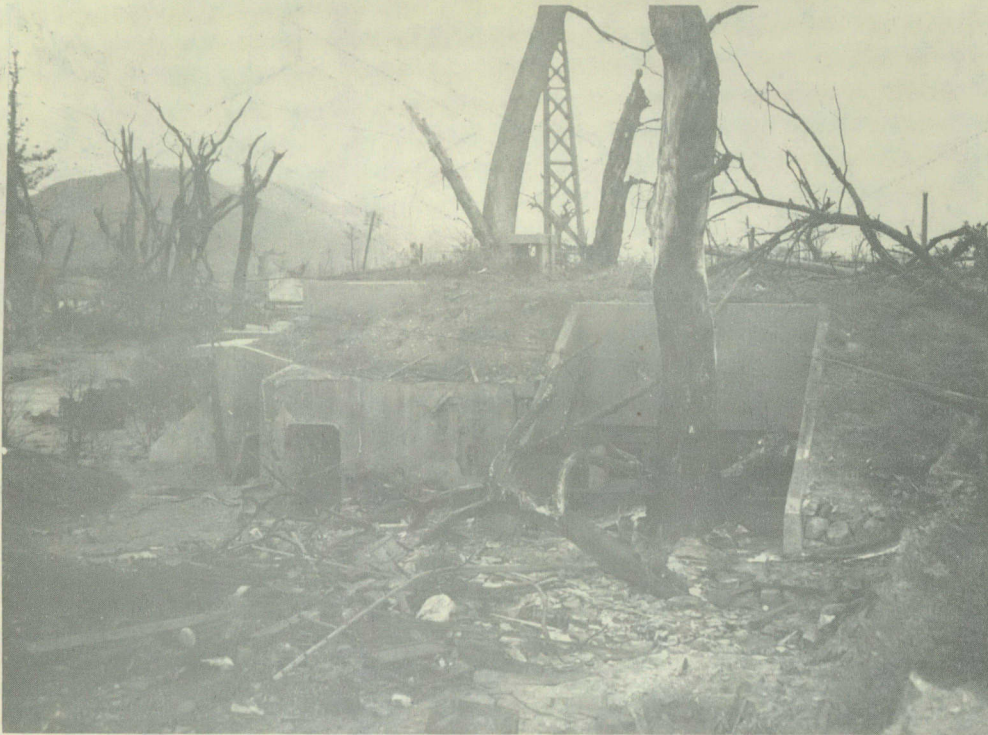
Figure 37--(11H). Chugoku Army Hq. (750 Meters). Underground Communications trench. Open metal port. Looking away from the center of the explosion, with which the optical axis of the camera is in line. (Photo File # HB 320; Date: 13 November 1945.)

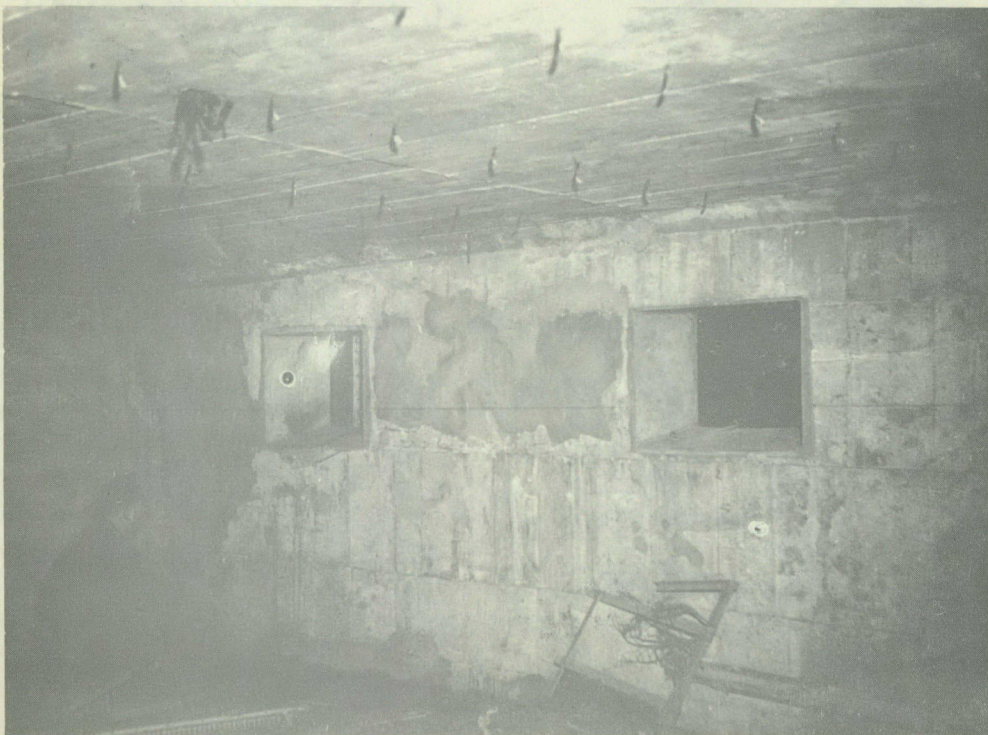
Figure 38--(11H). Chugoku Army Hq. (750 meters). Underground Communications trench. Entrance at left. (Photo File # HB 321; Date: 13 November 1945.)

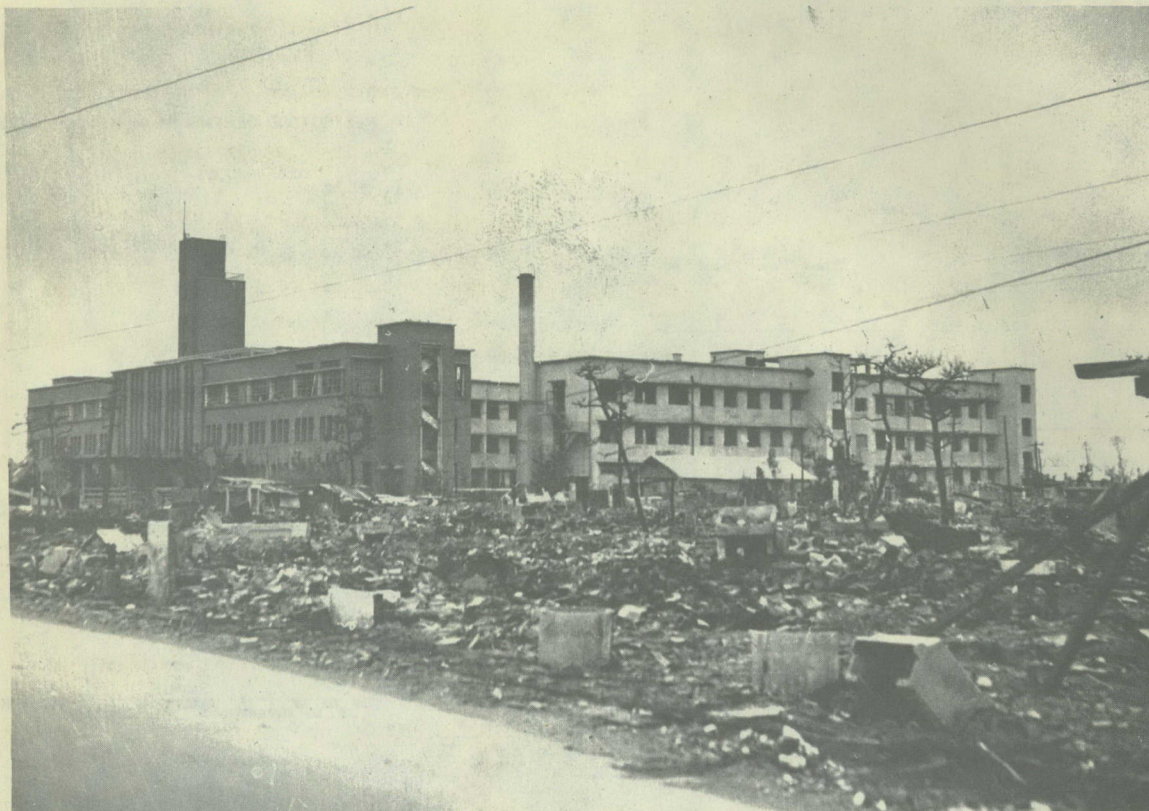
Figure 47--(11H). Red Cross Hospital (1600 meters). Showing Red Cross Hospital from direction of bomb center, 1.7 kilometers from center. Some windows have been repaired. Optical axis of camera in line with the hypocenter. (Photo File # HB 204 (K); Date: 27 November 1945.)
